# Building Condition Report (Various buildings)

| Building type: | <b>Office</b> |

| Report number: | <b>UK1234</b> |

| Report issuer: | <b>Inotek Analysis</b> |

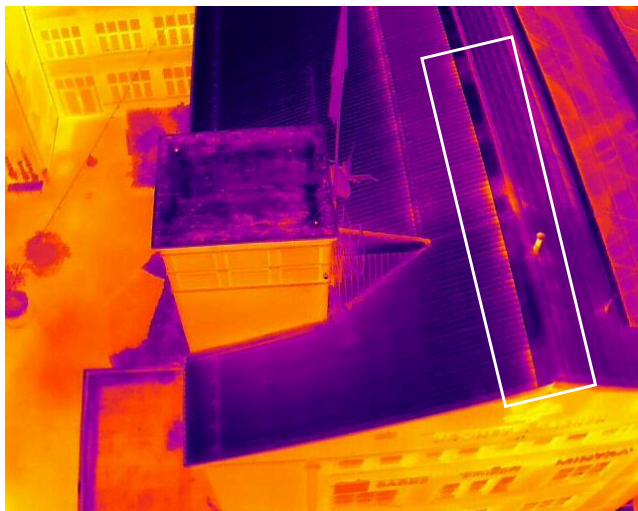
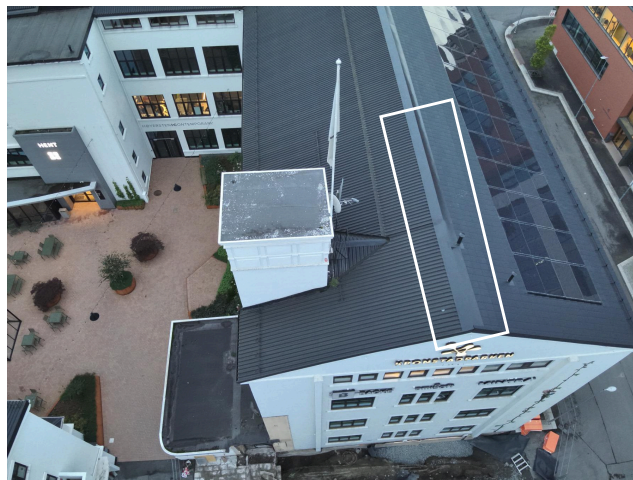
## Deviation 001 – Roof

RPL 3

Heat loss has been identified in the marked thermogram, indicating a thermal anomaly in the roof section. This suggests the presence of a thermal bridge, where heat is escaping through areas of insufficient insulation. The observable evidence from the thermogram highlights the specific locations where the temperature differential is significant. The extent of the issue appears to be localized, but it may have implications for overall energy efficiency and comfort within the building. The affected areas should be closely monitored for further signs of heat loss or moisture intrusion. Visual inspection may reveal additional clues regarding the integrity of the insulation in these regions.

The most likely cause of the heat loss is inadequate insulation at the thermal bridge locations. This can lead to increased energy consumption and potential discomfort for occupants. If left unaddressed, it may also result in moisture problems, which could compromise the building's structural integrity over time.

kWh: 390    CO<sub>2</sub> (kg): 48.3

Improve insulation in the identified areas to mitigate heat loss. Conduct regular inspections to ensure the effectiveness of the insulation. Consider implementing preventative measures to avoid future thermal bridging.

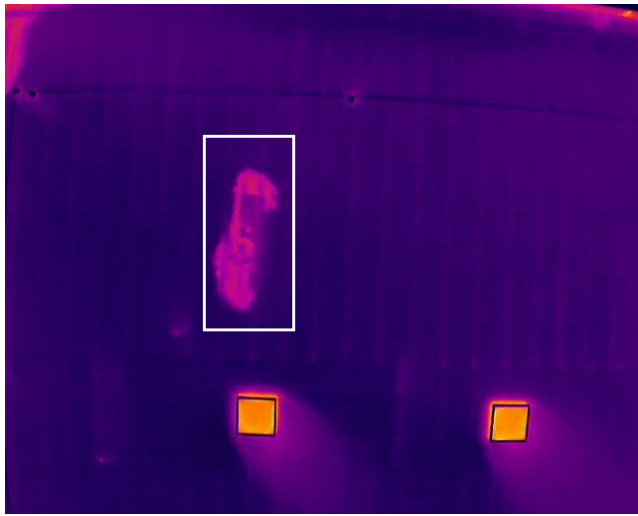
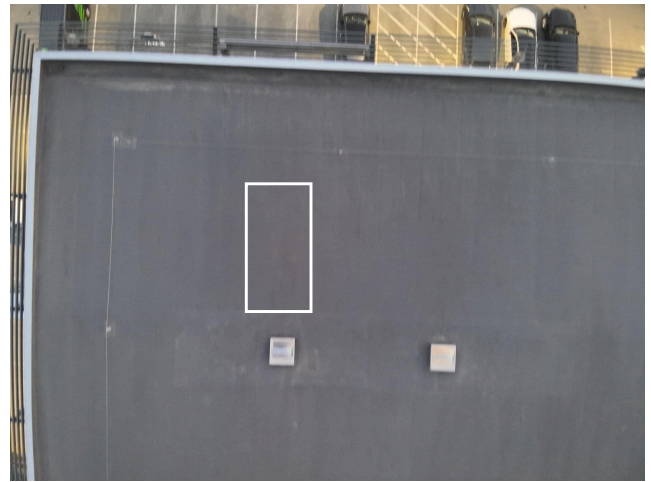
## Deviation 002 – Roof

RPL 3

Significant moisture accumulation has been detected beneath the roofing membrane, as evidenced by the attached thermal image. The affected area is located on the roof, where the insulation is likely compromised due to the presence of water. This condition poses a risk of further damage to the roofing structure and insulation materials. The extent of the moisture accumulation suggests a prolonged exposure to water, which could lead to mold growth and deterioration of building materials. Immediate attention is required to assess the full impact of this moisture intrusion.

The most likely cause of the moisture accumulation is a breach in the roofing membrane, allowing water infiltration. This can lead to significant risks, including structural damage, insulation failure, and potential health hazards due to mold growth. The uncertainty surrounding the extent of the damage necessitates a thorough investigation.

kWh: 412    CO<sub>2</sub> (kg): 82

Remove the wet insulation to prevent further damage. Repair the hole in the roofing membrane to stop water infiltration. Implement regular inspections to prevent future occurrences.

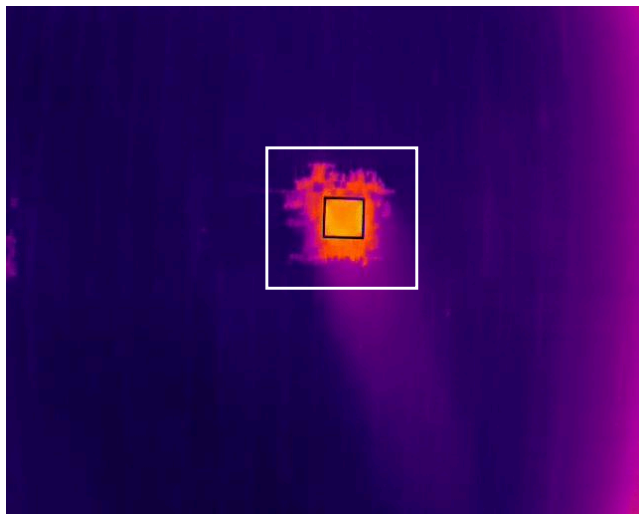
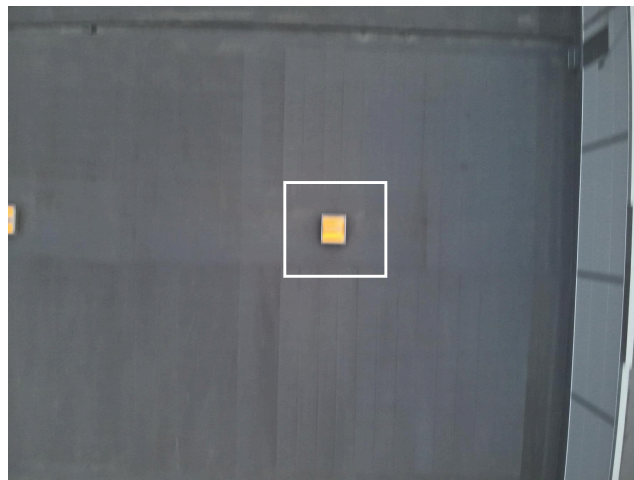
## Deviation 003 – Roof

RPL 3

There are significant challenges with condensation within the roof structure, as evidenced by the thermal imaging results. The issue is not visually apparent but is indicated by the thermal anomalies detected. Poor insulation around the skylight has been identified as a contributing factor to the condensation problem. The affected area includes the roof membrane and surrounding insulation, which may be compromised due to moisture accumulation. This situation suggests a potential risk of further damage to the roofing system if not addressed promptly. The extent of the problem requires careful evaluation to determine the full impact on the structural integrity of the roof.

The primary cause of the condensation is likely inadequate insulation around the skylight, leading to temperature differentials that promote moisture accumulation. If left unaddressed, this could result in mold growth, deterioration of building materials, and potential structural damage over time. The uncertainty lies in the extent of moisture penetration and its long-term effects on the roof structure.

kWh: 390    CO<sub>2</sub> (kg): 78

Remove the wet insulation and repair the affected areas. Re-roof the membrane to ensure proper sealing and insulation. Implement measures to improve insulation around the skylight.

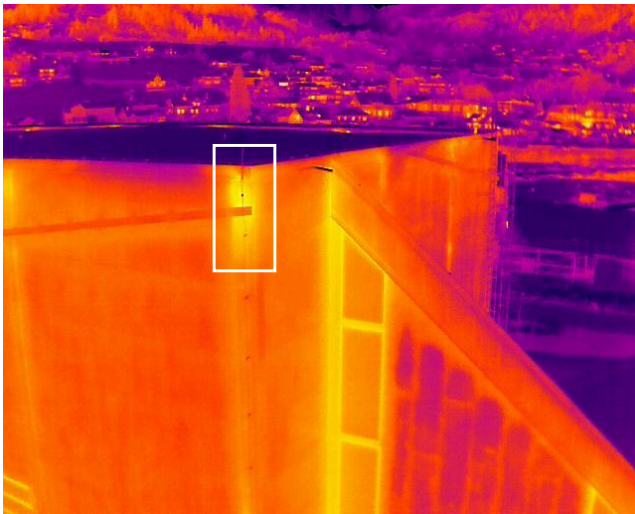
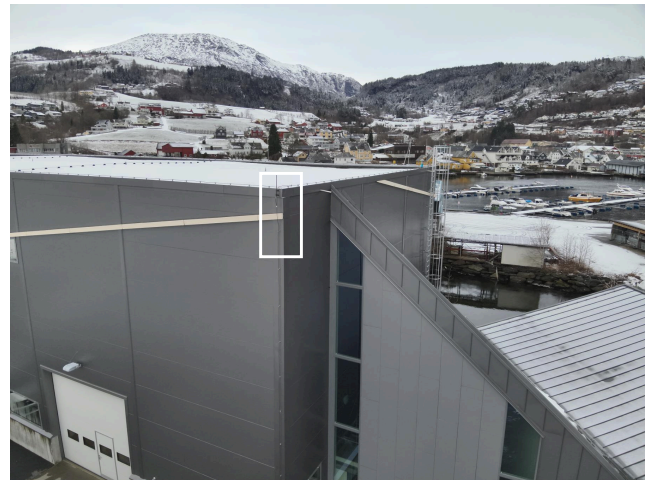
## Deviation 004 – Facade

RPL 2

A clear thermal bridge is evident in the marked area of the thermal image, although it is not visually observable. This indicates a potential issue with heat loss in the facade. Additionally, there is poor sealing observed at the outer corner, which may lead to condensation within the construction. The extent of the issue suggests that it could affect the overall thermal performance of the building. The thermal imaging highlights the discrepancy in temperature, indicating a significant deviation from expected thermal behavior. This could compromise the integrity of the building envelope over time.

The likely cause of the thermal bridge is inadequate insulation or a break in the thermal barrier at the marked location. Poor sealing at the outer corner exacerbates this issue, increasing the risk of moisture ingress and potential condensation within the structure. If left unaddressed, these conditions could lead to mold growth and deterioration of building materials.

kWh: 270    CO<sub>2</sub> (kg): 53,7

Dismantle the external cladding to access the affected area. Repair the sealing at the outer corner to prevent further moisture intrusion. Ensure proper insulation is reinstated to mitigate thermal bridging.

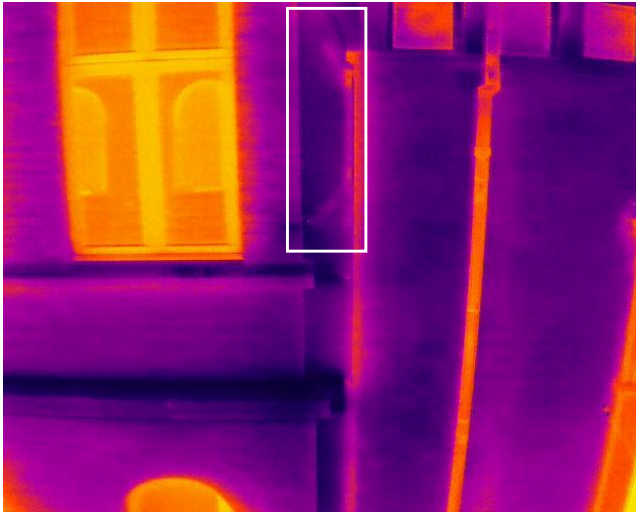
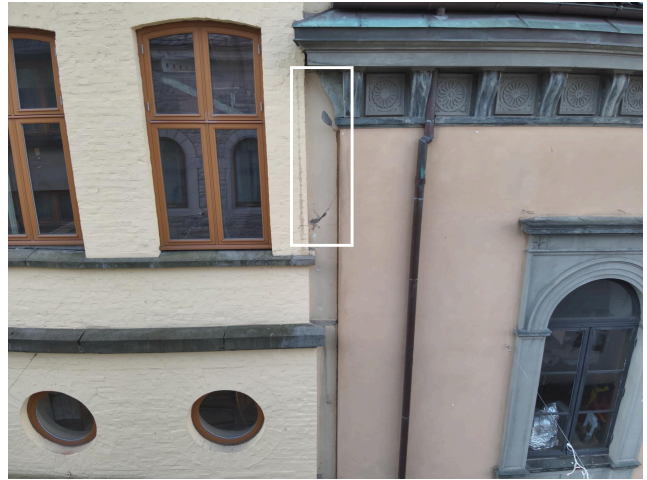
## Deviation 005 – Facade

RPL 3

Cracking has been observed in the facade, which is evident both thermally and visually. The cracks appear to be distributed across various sections of the facade, indicating a potential structural issue. The extent of the cracking suggests that it may be significant, warranting further investigation. The visual evidence shows irregular patterns of cracking that could compromise the integrity of the building. Thermal imaging may reveal temperature differentials associated with the cracks, suggesting underlying issues. The facade's condition raises concerns about its long-term durability and performance.

The exact cause of the cracking is uncertain, but it is likely related to settlement damage. Such damage can occur due to ground movement or inadequate foundation support. If left unaddressed, these cracks could lead to further structural deterioration and potential safety hazards.

Repairs should be conducted promptly to address the cracking in the facade. A thorough assessment of the foundation and surrounding soil conditions is recommended. Preventative measures should be implemented to mitigate future settlement issues.

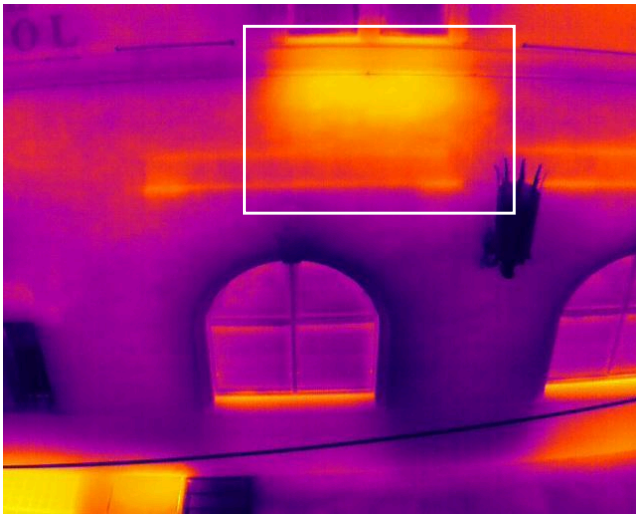
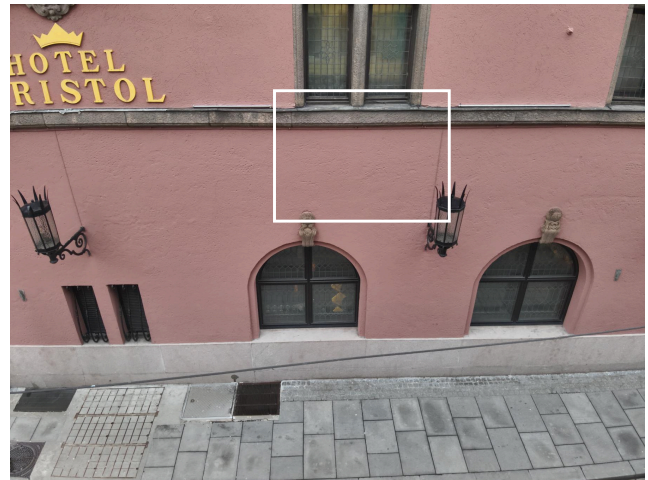
## Deviation 006 – Facade

RPL 2

Significant thermal bridging is observed at the base of the window, as evidenced by the marked thermal image indicating heat loss. This issue is primarily located where the window frame meets the adjacent construction. The extent of the thermal bridging suggests a considerable energy loss, which may impact the overall energy efficiency of the building. The insulation layer between the window frame and the adjoining structure is either limited or entirely absent, exacerbating the thermal inefficiency. This condition can lead to increased heating costs and potential discomfort for occupants due to drafts.

The most likely cause of this issue is inadequate or missing insulation at the junction between the window frame and the surrounding construction. This lack of proper insulation can result in significant energy loss and may lead to condensation issues, which could further damage the building fabric over time. Uncertainty exists regarding the full extent of the insulation deficiency without further investigation.

kWh: 1400    CO<sub>2</sub> (kg): 279

Repair the seal under the window to improve insulation. Ensure that proper insulation is installed between the window frame and adjacent construction. Regularly inspect and maintain window seals to prevent future issues.

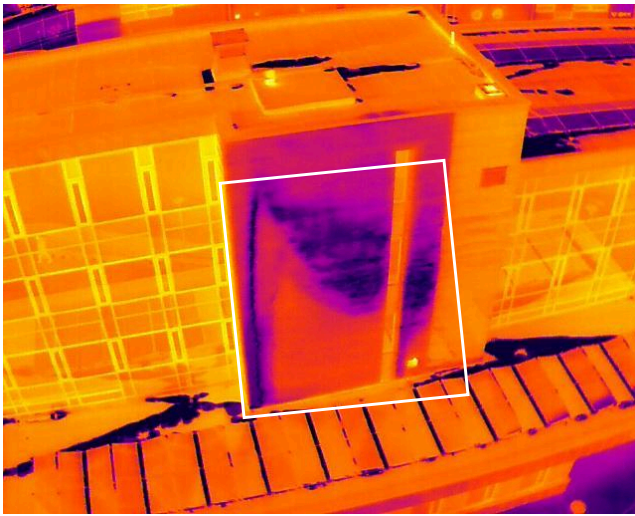
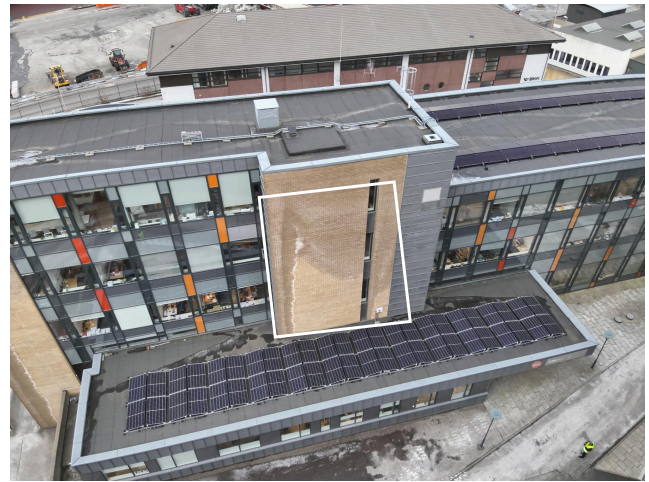
## Deviation 007 – Facade

RPL 3

Significant moisture retention has been observed in the construction, which is evident as darker areas in the attached thermal image. This moisture issue appears to be widespread, affecting various sections of the facade. The extent of the moisture infiltration suggests a potential underlying problem that requires further investigation. The affected areas are likely to compromise the integrity of the building materials and may lead to further deterioration if not addressed promptly. The presence of moisture can also create an environment conducive to mold growth, posing health risks to occupants. A thorough assessment is necessary to determine the full extent of the damage and the specific locations impacted.

The most likely cause of the moisture retention is a leak from the roof or parapet, which has allowed water to infiltrate the facade. This situation poses risks such as structural damage, mold growth, and potential health hazards for building occupants. The uncertainty regarding the exact source of the leak necessitates a detailed investigation to confirm the cause and extent of the moisture problem.

Conduct a thorough inspection to identify the source of the leak. Implement necessary repairs to the roof or parapet to prevent further moisture intrusion. Monitor the affected areas for any signs of recurring moisture issues.

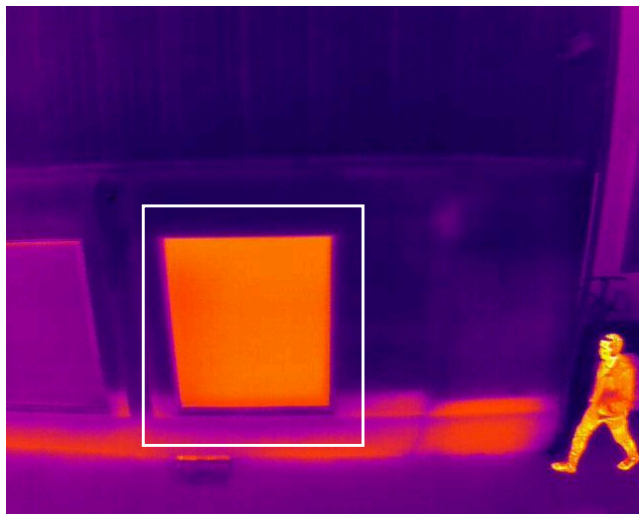
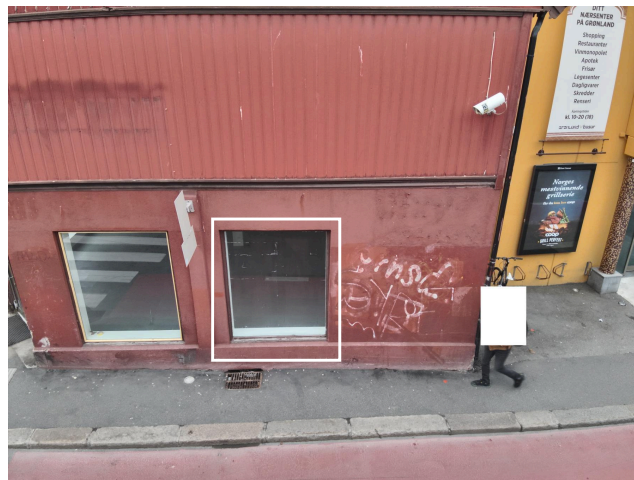
## Deviation 008 – Facade

RPL 2

The marked window exhibits clear signs of puncturing, which is visible upon inspection. This defect is characterized by the presence of air leakage between the glass layers, leading to a compromised thermal performance of the window. The issue is localized to the specific window indicated, and it affects the overall energy efficiency of the facade. The visual evidence suggests that the integrity of the window's seal has been breached, which may also lead to condensation or fogging between the panes. This condition can significantly impact the comfort and energy consumption of the building. The extent of the problem appears to be limited to this particular window, but it may indicate broader issues if not addressed promptly.

The primary cause of the observed issue is likely due to a failure in the sealant or the glass itself, resulting in puncturing. This failure can lead to increased air infiltration, which negatively affects the window's U-value and overall energy efficiency. If left unaddressed, this could result in further deterioration of the window and increased energy costs for heating or cooling. There is some uncertainty regarding whether the damage is isolated or indicative of a more systemic problem within the facade.

kWh: 1150    CO<sub>2</sub> (kg): 229

The window should be repaired or replaced to restore its integrity and thermal performance. Regular inspections of window seals and glass should be conducted to prevent similar issues in the future.

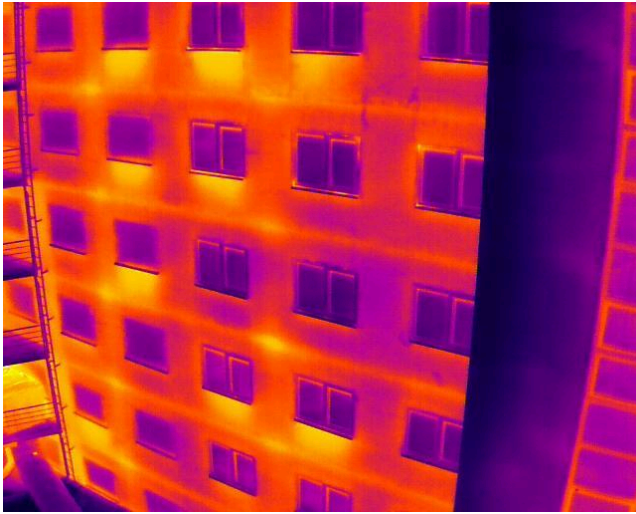
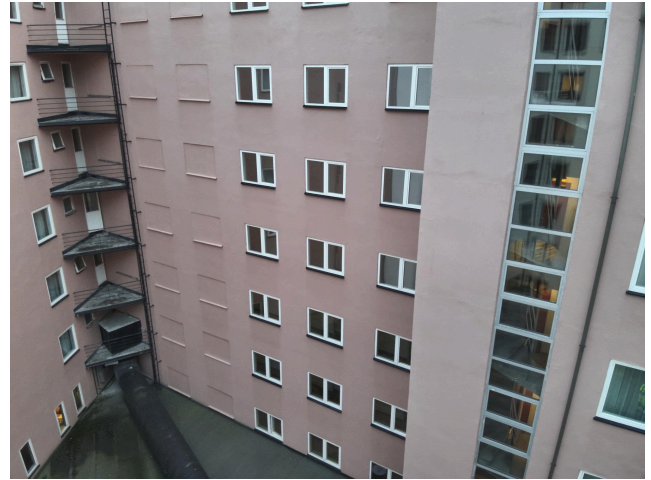
## Deviation 009 – Facade

RPL 2

Significant heat loss is observed from all windows in the marked facade. The heat loss is primarily prominent at the bottom of the windows. This condition leads to considerable energy loss and condensation, which adversely affects the condition of both the windows and the surrounding construction. The issue is particularly noticeable in the lower sections of the window frames. Visual inspection reveals gaps and potential signs of moisture accumulation. The extent of the problem suggests a systemic issue with the window installations.

The likely cause of the heat loss is poor or missing sealing and insulation between the bottom frame of the windows and the surrounding construction. This deficiency can lead to increased energy costs and potential structural damage over time due to moisture infiltration and condensation.

kWh: 18300    CO<sub>2</sub> (kg): 3641

Improve the sealing by adding insulation or foam between the window frames. Ensure that all gaps are properly filled to prevent future heat loss. Regular maintenance checks should be implemented to monitor the condition of the seals.
